HULL CONDITION REPORT

s.s.n.b MONOUCHE

Dated: 2nd November 2021 **Client: ██████████**

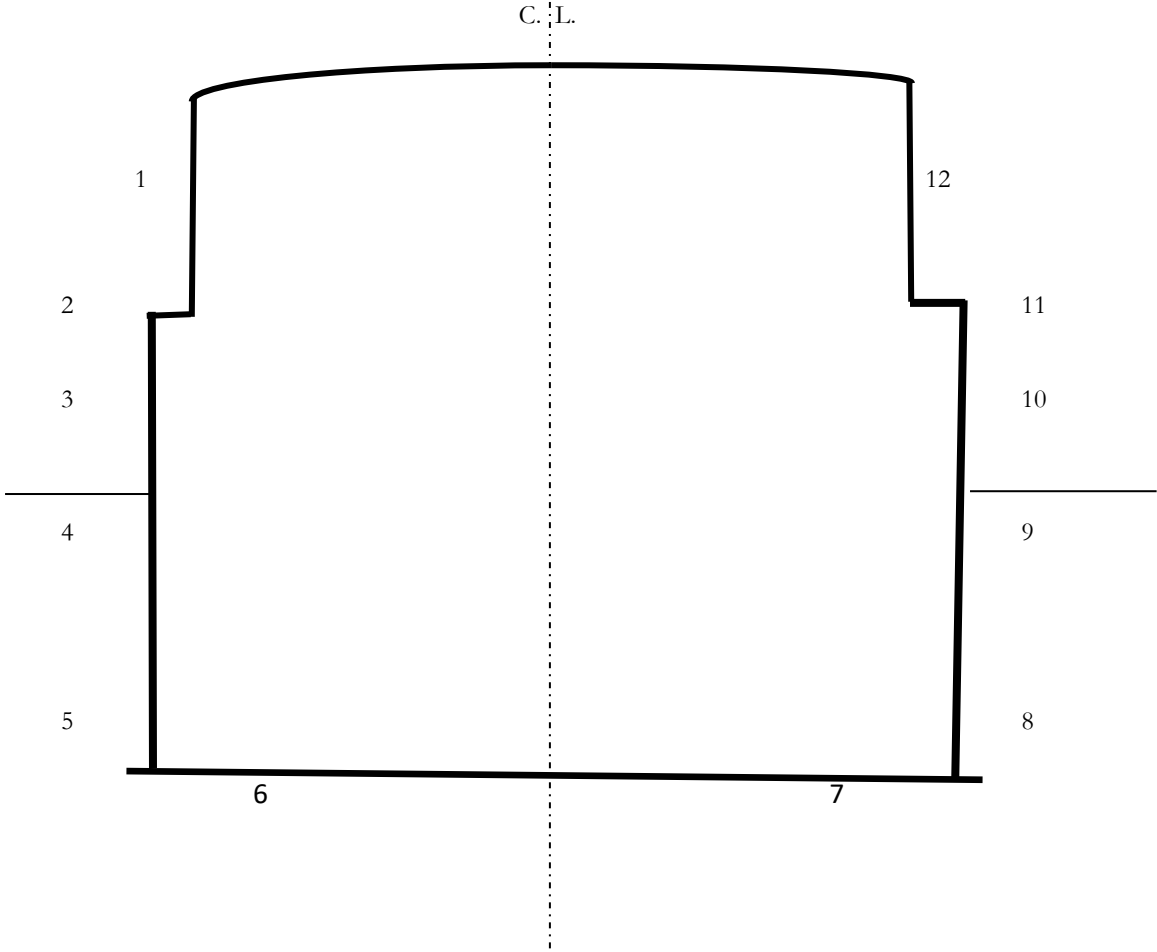
a Midship Section.

The side shell readings - some 60 in number - which also, as might be expected, again approximately followed the normal distribution, had a range from 5.80 mm to 6.10 mm. with a median of 5.90 mm and gave an arithmetic mean reading of about 5.93 mm with a mean deviation of ± 0.07 mm. Again, as stated, the points measured were randomly selected and the number of readings taken was based on a statistically significant percentage of the side surface area of the vessel. The thickness readings were found to be generally very good. It was noted there was some historic pitting below the water line which should be examined at each docking.

The sketch below shows a typical section for the vessel looking forward and the approximate positions round the hull at which the readings were taken.
